301 TURBO CHARGE DISPLAY

Leveraging Multi Jet Fusion to reproduce an OEM-accurate Turbo Charge boost indicator for the 1980-1981 Turbo Trans Am.

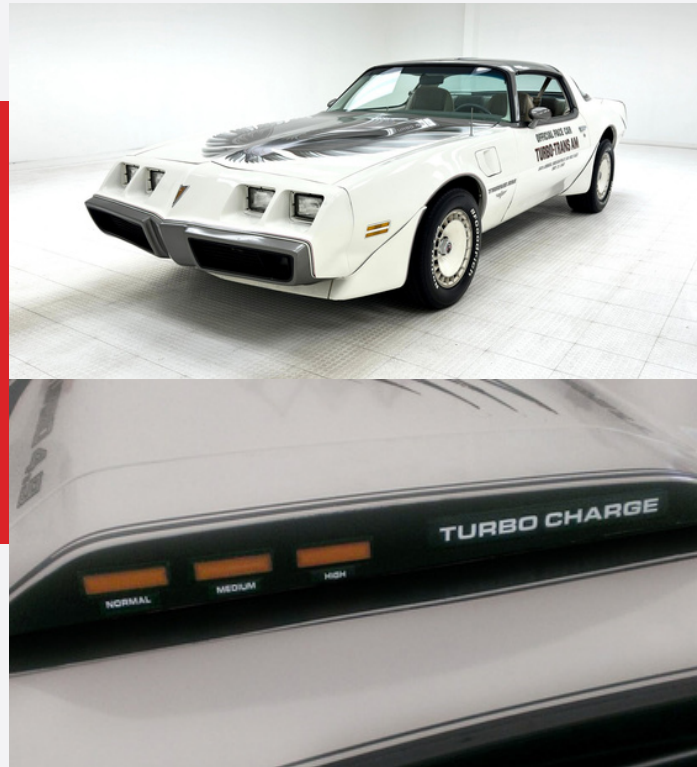
The original Turbo Charge indicator, injection-molded with an orange plastic base and hand-painted with black paint, suffered from cracking and degradation due to engine heat and UV exposure. With no available replacements, original owner Paul Pinto sought a reliable solution to digitize and reproduce the part to exact specifications

Endeavor 3D partnered with Southwest Equipment, Inc. to bring the design to life using Multi Jet Fusion (MJF) technology and Nylon PA 12 material. This solution provided enhanced durability and aesthetic precision while offering a cost-effective alternative to injection molding. The manufacturing process included prototyping, iterative adjustments, and quality improvements to ensure the final product met the OEM standard.

By using Nylon PA 12, Endeavor 3D improved the part's resistance to heat and UV damage, resolving the cracking and fading issues of the original part.
